magicolor[®] 330

Service Manual

November 2000
1750049-001B

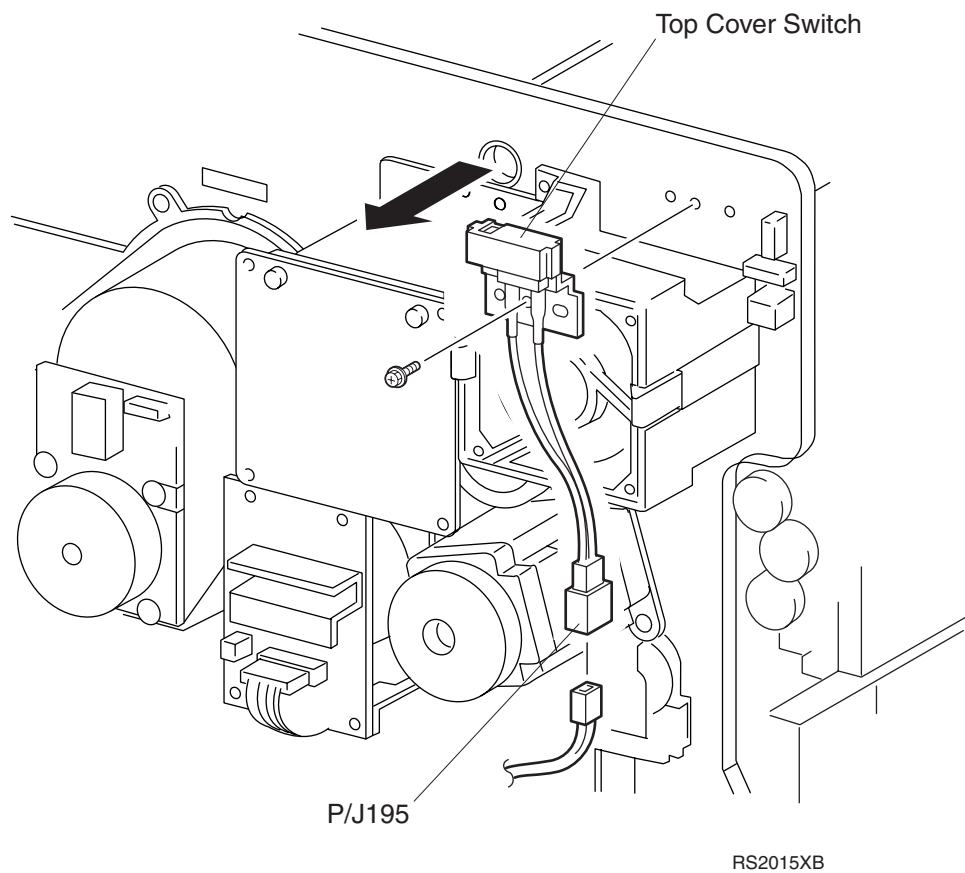
RRP 9.121 Top Cover Switch (PL13.1.3)

1. Line up the two positioning holes and the screw hole in the Top Cover Switch with the two positioning tabs and the screw hole in the printer frame.
2. Use one screw to secure the Top Cover Switch to the printer frame.
3. Reconnect P/J 195 to the Top Cover Switch.
4. Reinstall the Top Cover Assembly (RRP 9.3).

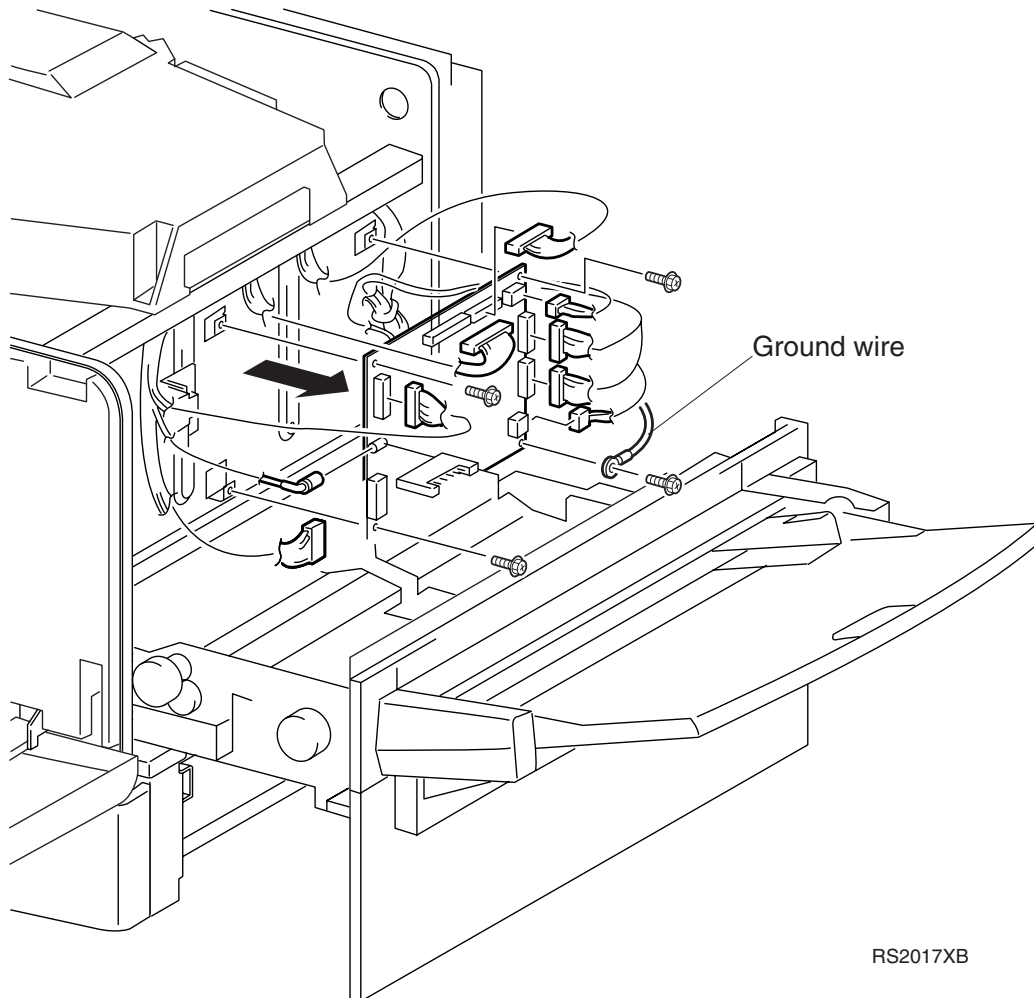
RRP 9.123 MCU PWB (PL13.2.1)

1. Position the MCU PWB so the text printed on the PWB is right side up.
2. Reinstall the MCU PWB onto the printer frame.
3. Reinstall the Ground Wire onto the bottom right screw hole in the MCU PWB and use one screw to secure the Wire.
4. Reinstall the Ground Wire onto the top left screw hole in the MCU PWB and use one screw to secure the Wire.
5. Use two screws to finish secure the MCU PWB to the printer frame.
6. Reconnect the nine P/Js to the MCU PWB.
7. Reinstall the Controller Chassis Assembly (RRP 9.127).
8. Write all of the old Life Counter values onto the new MCU PWB (see Section 9).

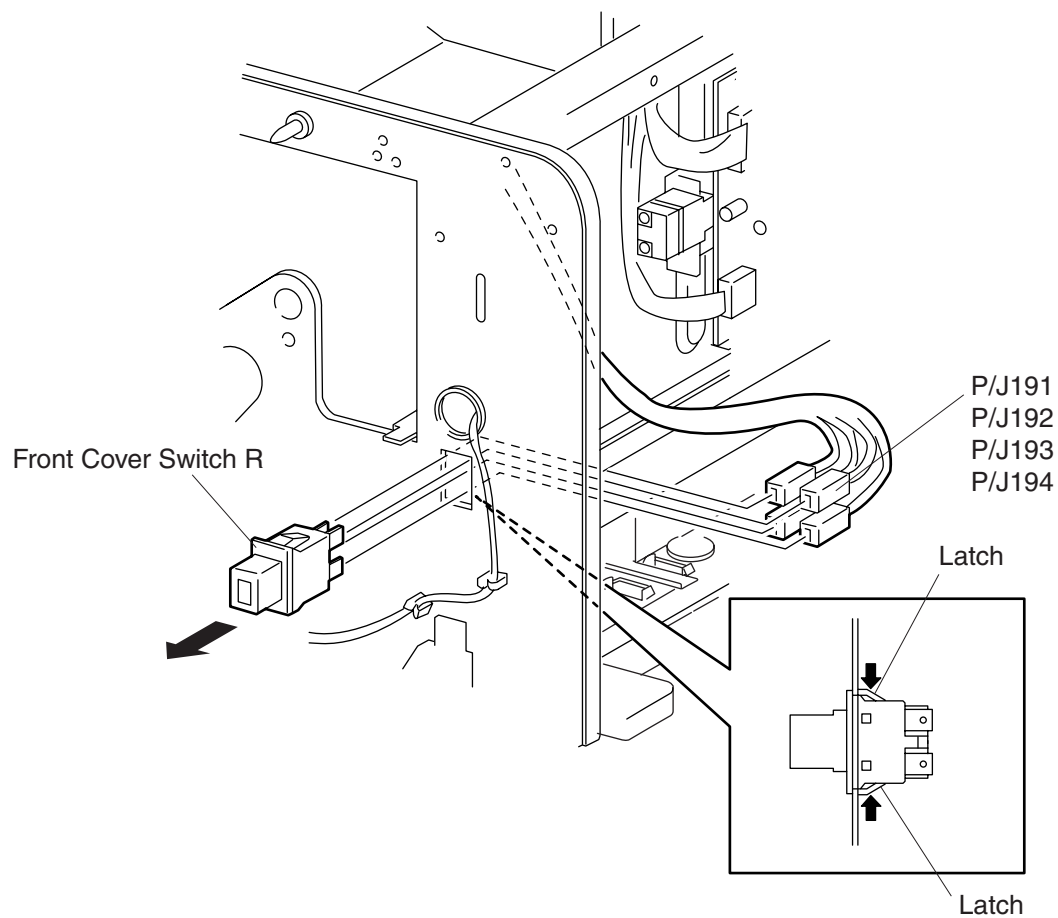
RRP 9.124 Front Cover Switch R (PL13.2.3)

1. Slide the Front Cover Switch into the cutout in the front of the printer frame.
The latches snap into place.
2. Reconnect the P/J191, P/J192, P/J193, and P/J194 to the Front Cover Switch.
3. Reinstall the Controller Chassis Assembly (RRP 9.127).

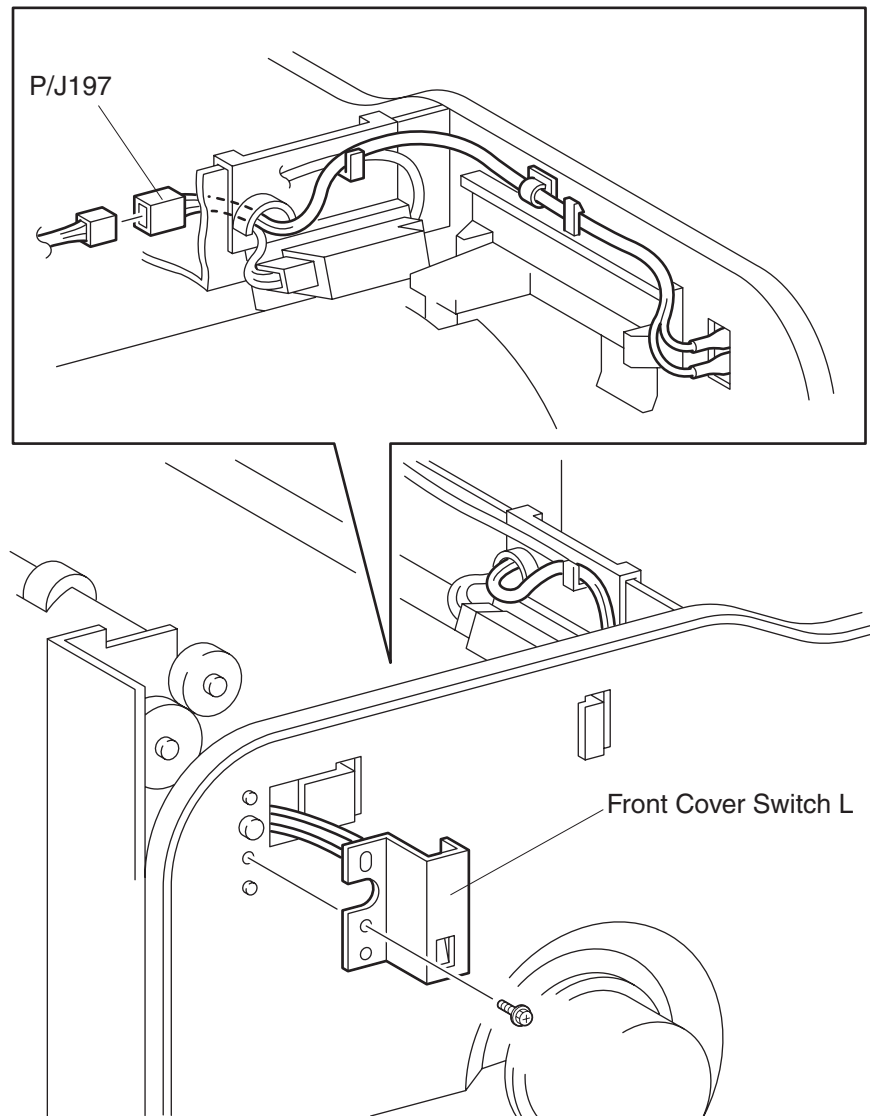
RRP 9.125 Front Cover Switch L (PL13.2.4)

1. Reinstall the Front Cover Switch L into the cutout in the printer frame.
2. Secure the Switch wire harness under the wire clips.
3. Reconnect P/J197 to the Front Cover Switch L.
4. Reinstall the Top Cover (RRP 9.3).
5. Reinstall the Inner Cover (RRP 9.2).

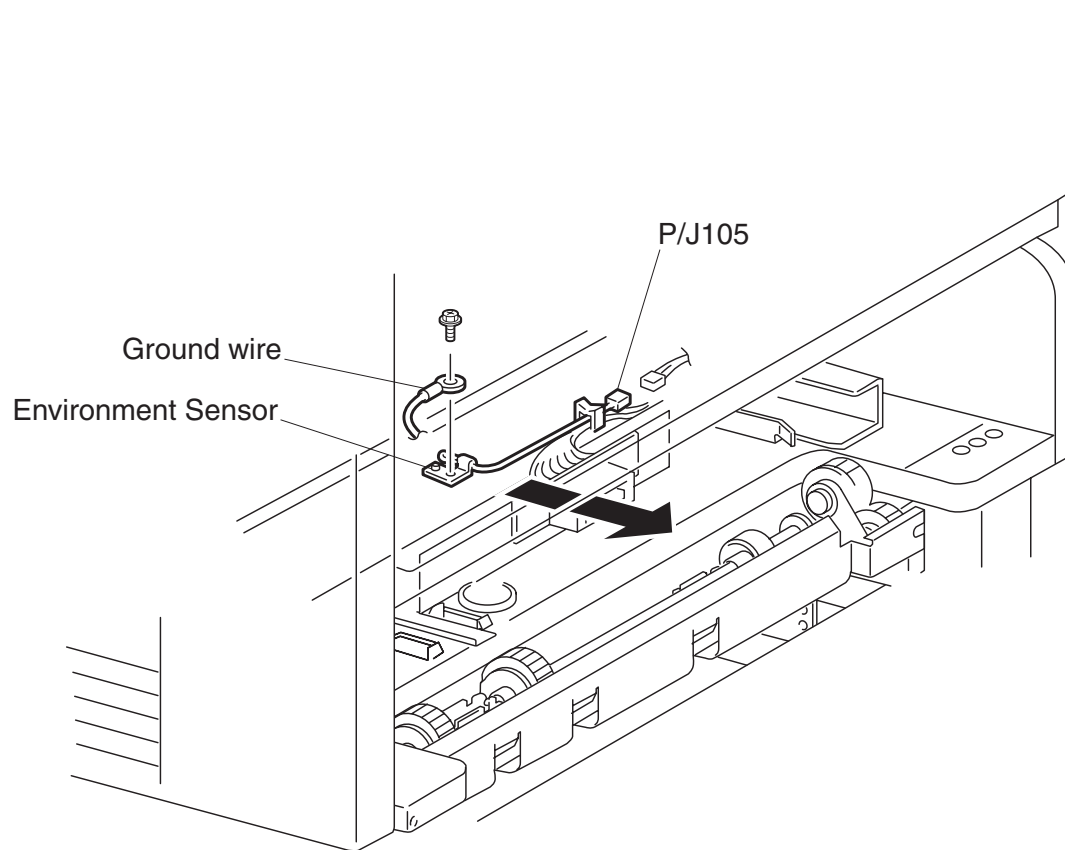
RRP 9.126 Environment Sensor (PL13.2.5)

1. Reinstall the Environment Sensor onto the printer frame.
2. Align the Sensor so the positioning hole and the screw hole in the Sensor line up with the positioning tab and screw hole in the printer frame.
3. Reinstall the Ground Wire over the screw hole in the Sensor.
4. Use one screw to secure the Sensor and Ground Wire to the frame.
5. Reconnect P/J 105 to the Environment Sensor.
6. Slide the Main Paper Handling Assembly into the printer.
7. Reinstall the Xerographic Cartridge (RRP 9.48).

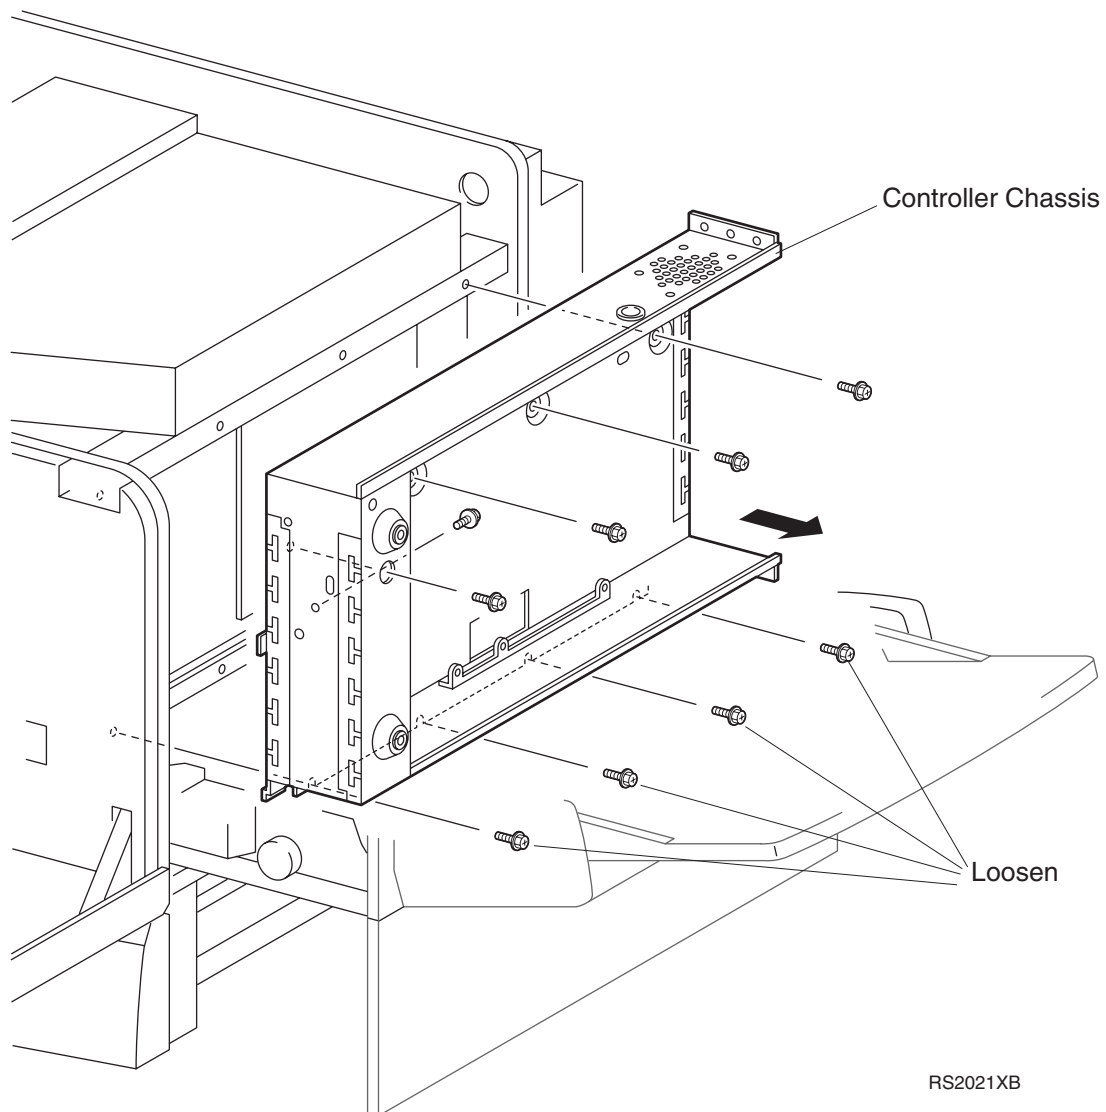
RRP 9.127 Controller Chassis Assembly (PL14.1.1)

1. Remove the Controller Fan (RRP 9.128).
2. Remove the Controller PWB (RRP 9.129).
3. Slide the Main Paper Handling Assembly several inches out of the printer engine.
4. Loosen, but do not remove, the four screws securing the bottom of the Controller Chassis Assembly to the printer frame.
5. Remove the four screws securing the top of the Controller Chassis Assembly to the printer frame.
6. Lift the Controller Chassis Assembly up and off of the four loosened screws at located at the bottom of the Chassis, and remove the Chassis Assembly from the printer frame.

1. Slide the Main Paper Handling Assembly several inches out of the printer engine.
2. Lower Controller Chassis Assembly onto the printer frame so the four notches located at the bottom of the Controller Chassis Assembly slide behind the four loosened screws on the printer frame.
3. Use four screws to secure the top of the Controller Chassis Assembly to the printer frame.
4. Tighten the four screws at the bottom of the Controller Chassis Assembly.
5. Reinstall the Controller PWB (RRP 9.129).
6. Reinstall the Controller Fan (RRP 9.128).

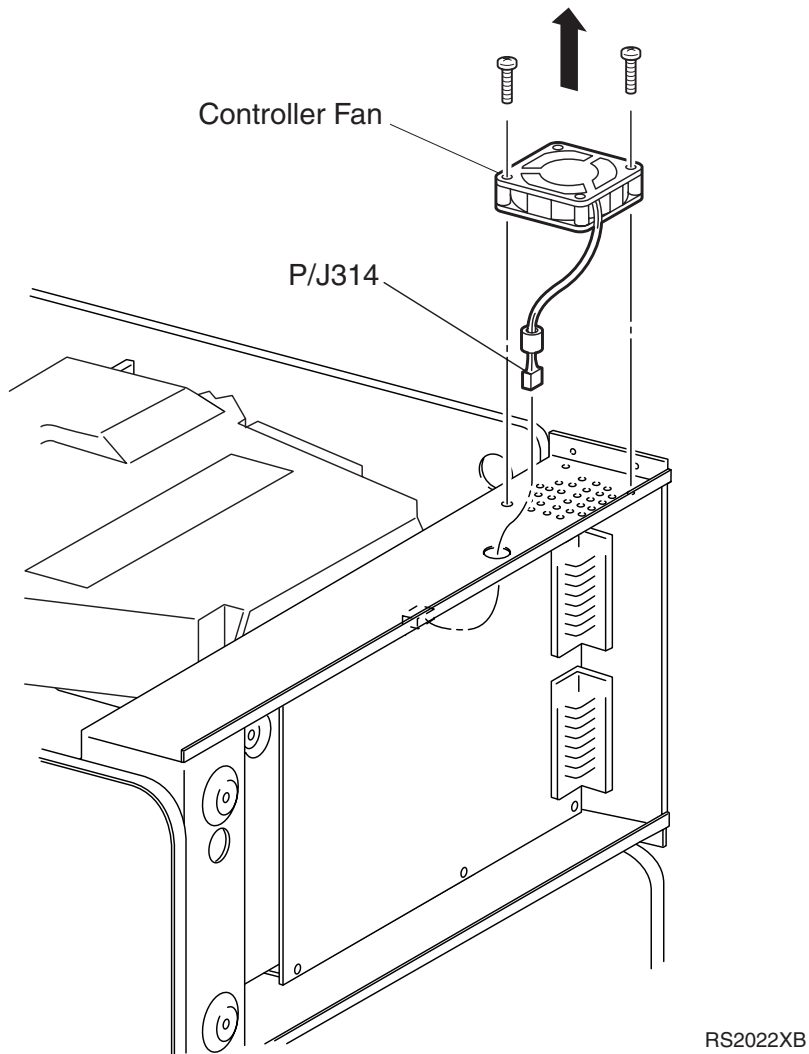
RRP 9.128 Controller Fan (PL14.1.2)

1. Position the Controller Fan with the label facing up and the wires close to the grommet hole.
1. Reinstall the Fan onto the printer frame.
2. Use two screws to secure the Fan to the printer frame.
3. Route the Fan wire through the grommet hole.
4. Reconnect the Controller Fan P/J 314 to the Controller PWB.
5. Reinstall the Top Cover (RRP 9.3).
6. Reinstall the Right Cover (RRP 9.8).

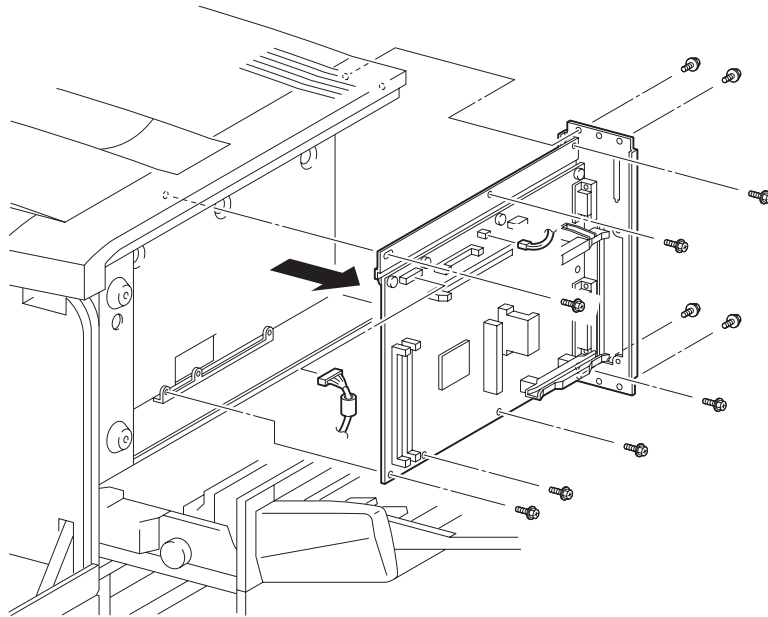
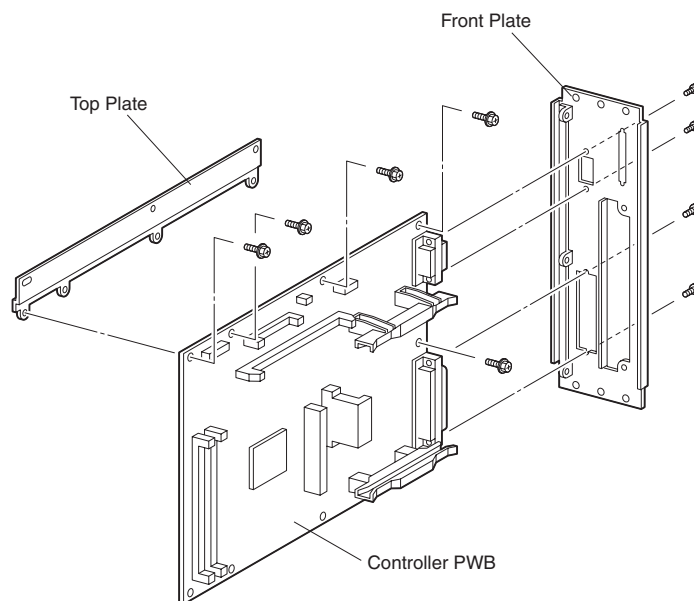
RRP 9.129 Controller PWB (PL14.1.10)

1. Reinstall the End Plate onto the Controller PWB and use four screws to secure the End Plate.
2. Reinstall the Top Plate onto the Controller PWB and use four screws to secure the Top Plate.
3. Position the Controller PWB so the P/J on the back of the Controller lines up with P/J 11 on the MCU PWB.
4. Press the Controller PWB against the Controller Chassis so the P/J on the back of the Controller connects with P/J 11 on the MCU PWB.
5. Use eleven screws to secure the Controller PWB to the Controller Chassis.
6. Reconnect all P/J's to the Controller PWB.
7. Reinstall the Right Cover Assembly (RRP 9.8).
8. Reconnect all interface cables to the Controller PWB.

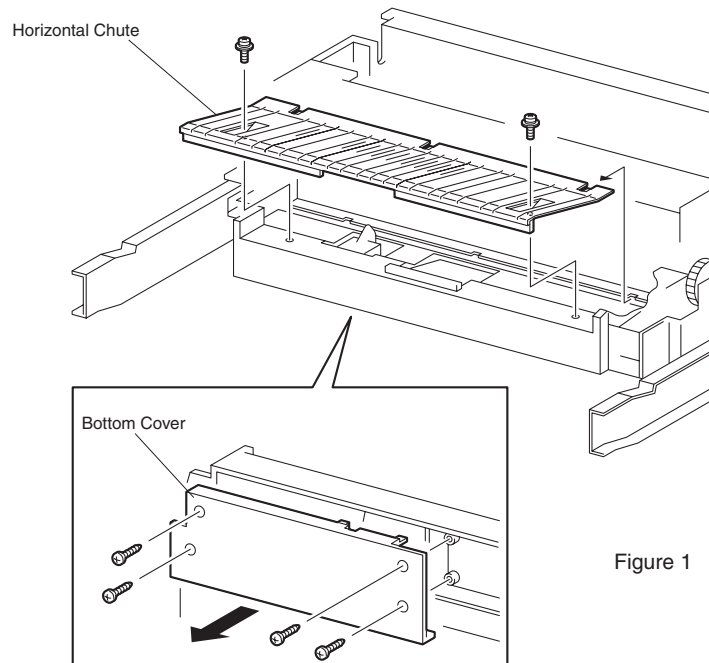
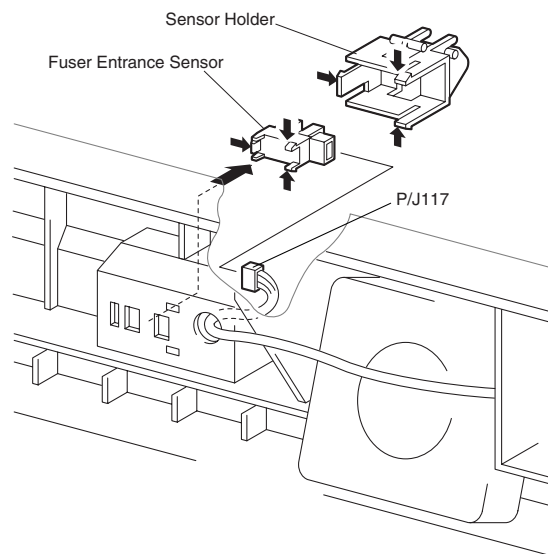
RRP 9.130 Fuser Entrance Sensor (PL9.4.4)

1. Reinstall the Fuser Entrance Sensor by pressing the latches on the bottom of the Sensor into the holes in the Fuser Tray.
The Sensor snaps into place.
2. Reconnect P/J 117 to the Fuser Entrance Sensor.
3. Reinstall the Fuser Entrance Sensor Holder by placing the Holder over the reinstalled Sensor, then pressing the latches on the bottom of the Holder into the holes in the Fuser Tray.
The Holder snaps into place.
4. Reinstall the Bottom Cover onto the Fuser Tray and use four screws to secure the Cover.
5. Reinstall the Horizontal Chute onto the Fuser Tray and use two screws to secure the Chute.
6. Reinstall the Fuser Assembly (RRP 9.80).

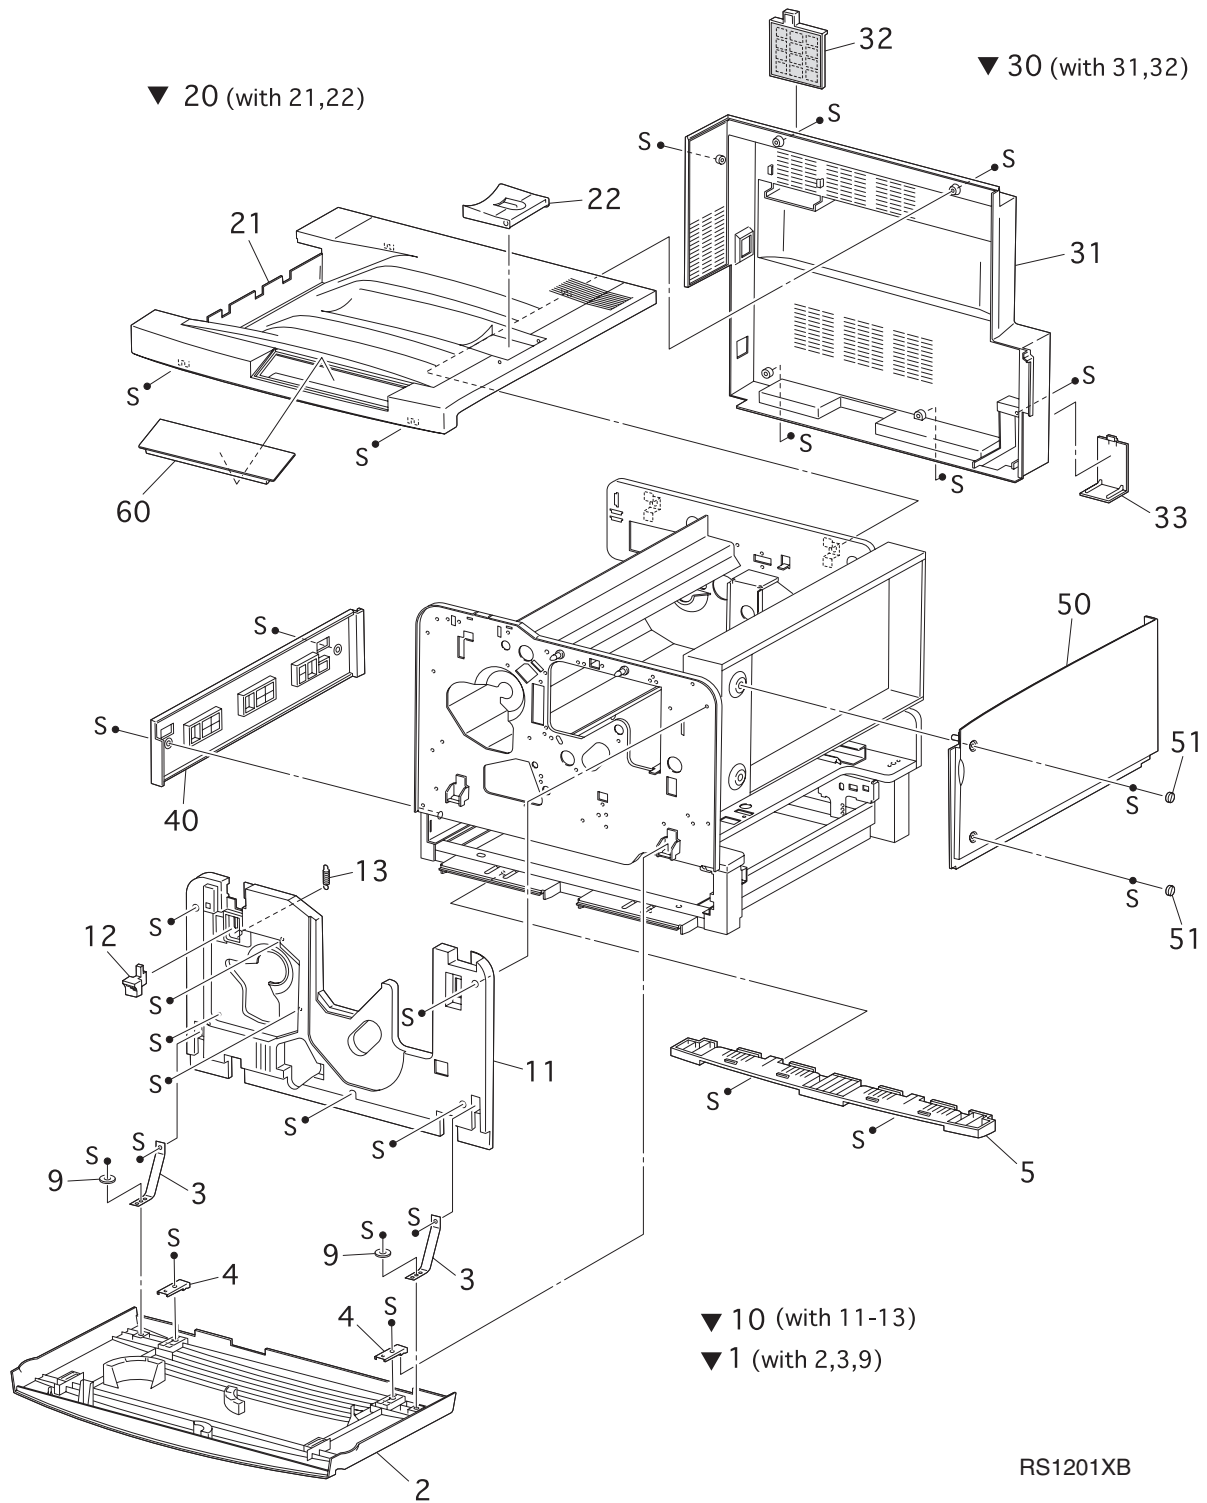
PL1.1 Cover

1. FRONT COVER ASSEMBLY (with 2, 3, and 9)	P/N 865600K69100
2. FRONT COVER SUB ASSEMBLY	N/A
3. COVER SUPPORT	N/A
4. HINGE PLATE.....	N/A
5. FRONT LOWER COVER	P/N 865048E52290
9. SUPPORT WASHER.....	N/A
10. INNER COVER ASSY (with 11~13)	P/N 865048K76171
11. INNER COVER.....	N/A
12. ROTARY LATCH LEVER.....	P/N 865600K69091
13. ROTARY LATCH SPRING	N/A
20. TOP COVER ASSEMBLY (with 21 and 22).....	P/N 865802K04720
21. TOP COVER	N/A
22. STOPPER COVER.....	P/N 865048E49530
30. REAR COVER ASSEMBLY (with 31 and 32).....	P/N 865600K69112
31. REAR COVER	N/A
32. FILTER ASSEMBLY	P/N 865053K91391
33. O/H COVER.....	P/N 865048E52301
40. LEFT LOWER COVER	P/N 865048E49570
50. RIGHT COVER ASSEMBLY	P/N 865048K40705
51. SCREW CAP.....	N/A
60. OPERATION PANEL	P/N 865048K70442

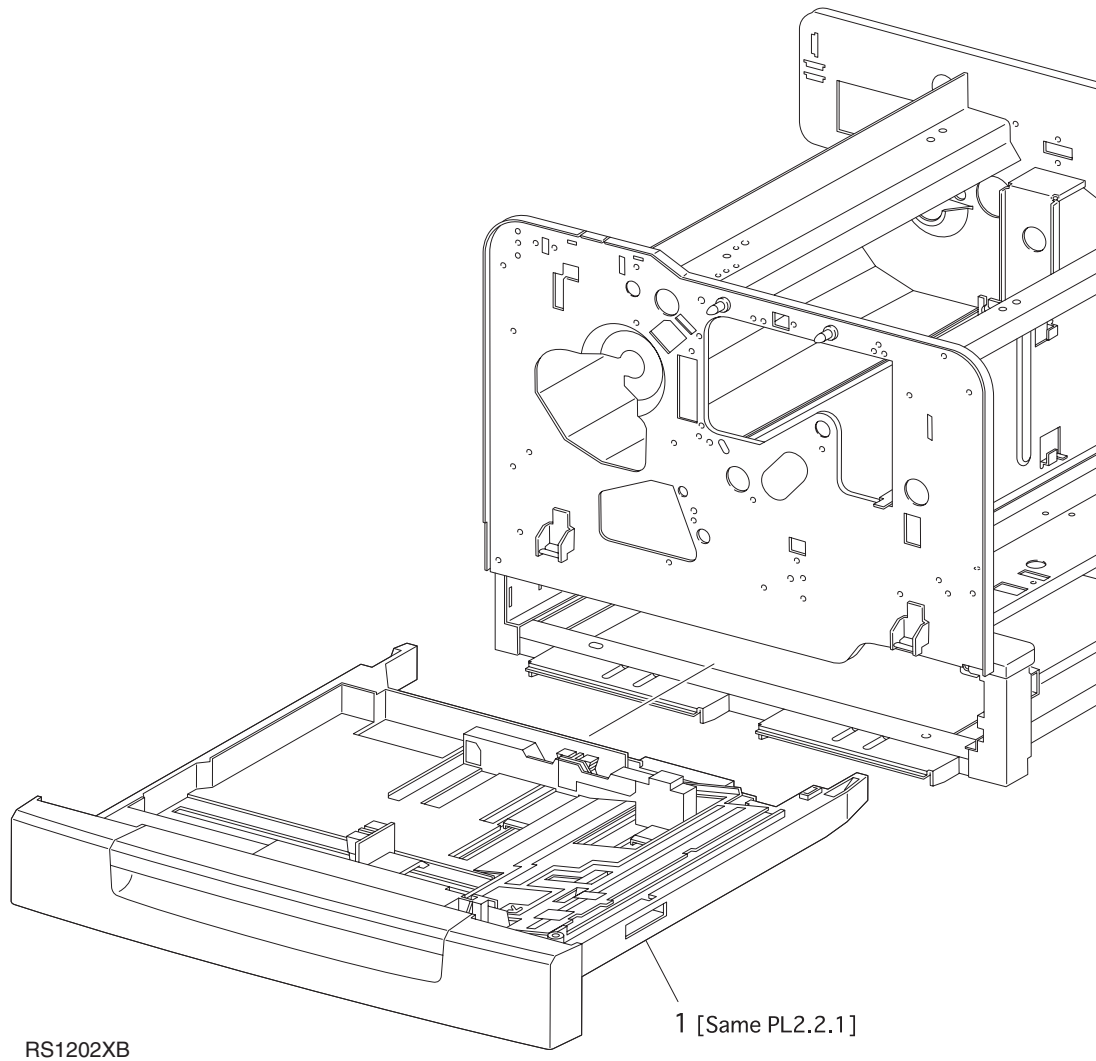
PL2.1 Paper Tray I

- 1. UNIVERSAL CASSETTE (Standard Tray, same as PL2.2.1)..... P/N 1710317-001
- 1. OVERSIZE CASSETTE P/N 1710318-001
- 1. OVERHEAD PROJECTION (OHP) CASSETTE P/N 1710319-001

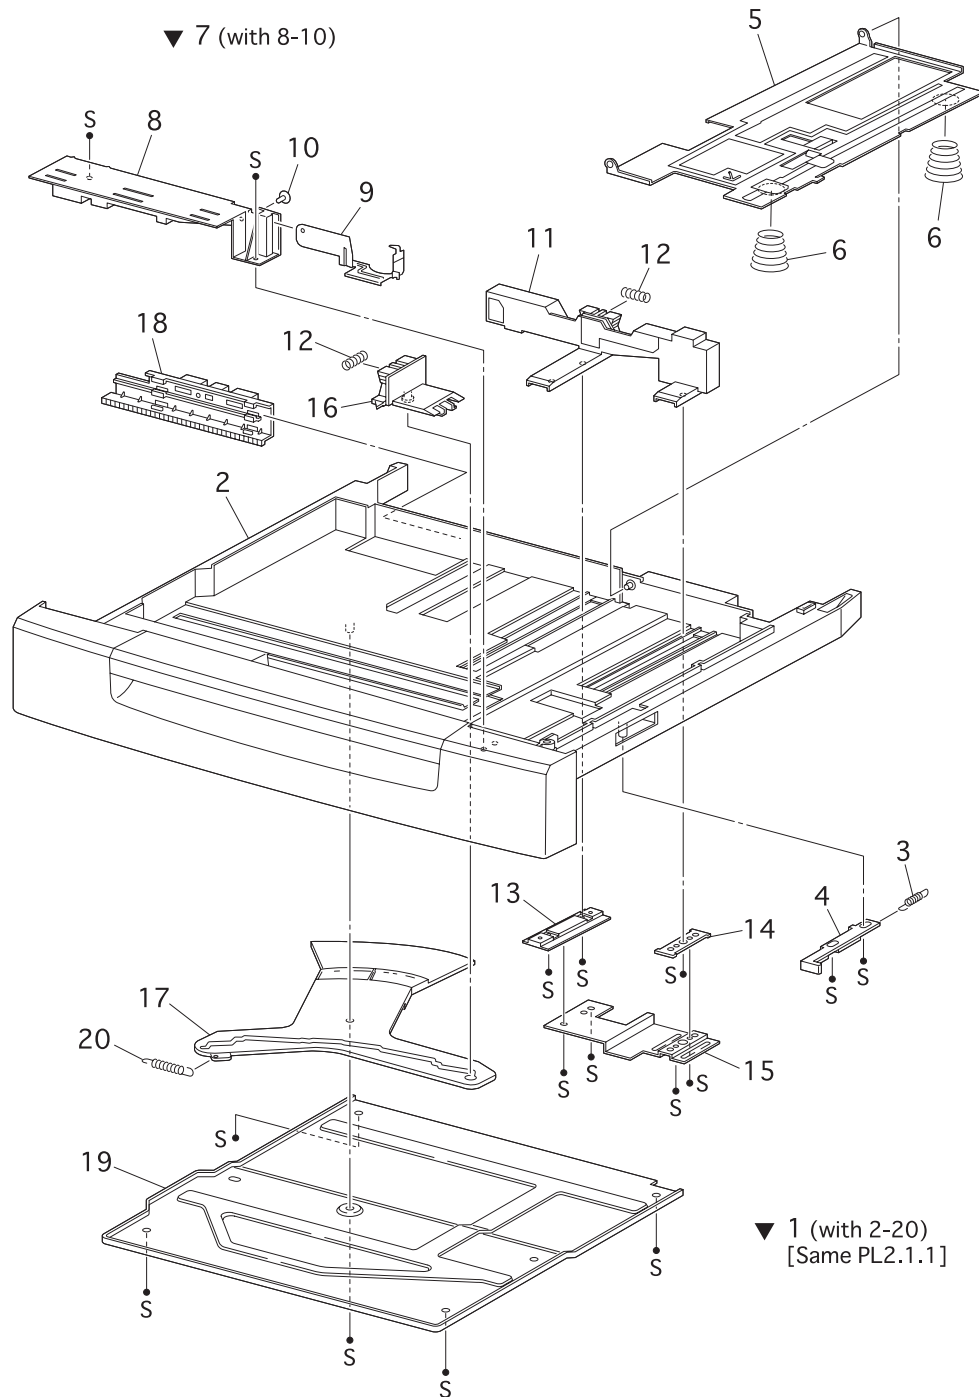
PL2.2 Paper Tray II

1. UNIVERSAL CASSETTE (with 2~20) (Standard Tray, same as PL2.1.1).....P/N 1710317-001
2. TRAY HOUSING
3. PLATE LINK SPRING
4. PLATE LINK
5. BOTTOM PLATE ASSEMBLY
6. TRAY N/F SPRING
7. FRONT GUIDE ASSY (with 8~10)
8. FRONT GUIDE
9. FRONT SNUBBER
10. SNUBBER STOPPER
11. REAR GUIDE ASSEMBLY
12. GUIDE SPRING
13. REAR GUIDE PLATE L
14. REAR GUIDE PLATE R
15. LOCK PLATE
16. END GUIDE
17. SECTOR GEAR
18. TRAY SIZE ACTUATOR
19. TRAY BOTTOM COVER
20. SECTOR GEAR SPRING

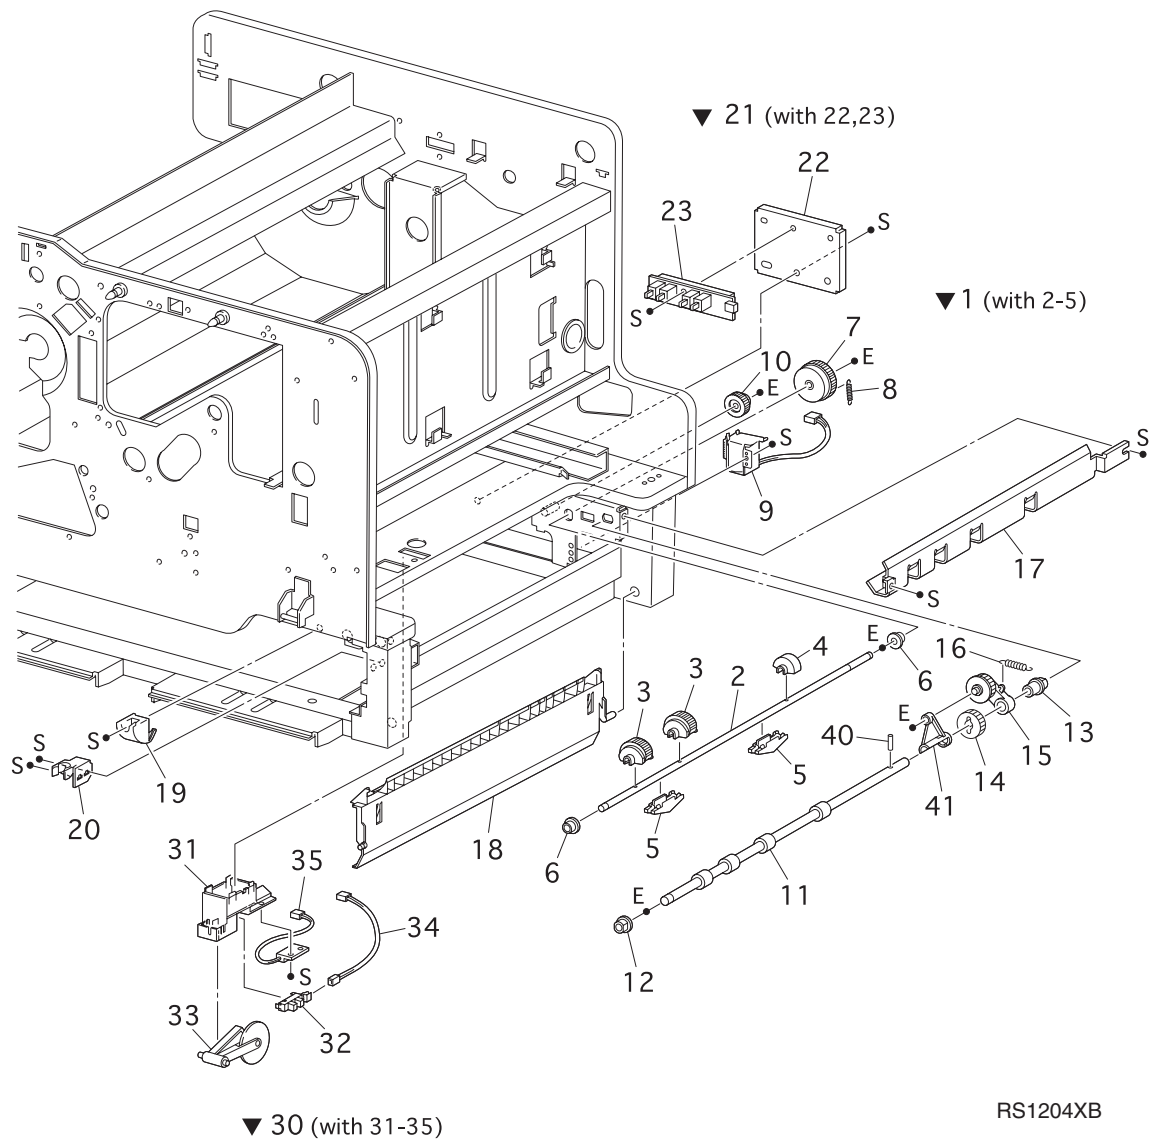
PL3.1 Paper Feeder

1. FEED ROLL ASSEMBLY (with 2~5).....	P/N 865048E52290
2. FEED SHAFT	N/A
3. FEED ROLL	P/N 865600K73770
4. FEED CORE ROLL	N/A
5. FEED ROLL GUIDE	N/A
6. FEED BEARING.....	P/N 865013E80210

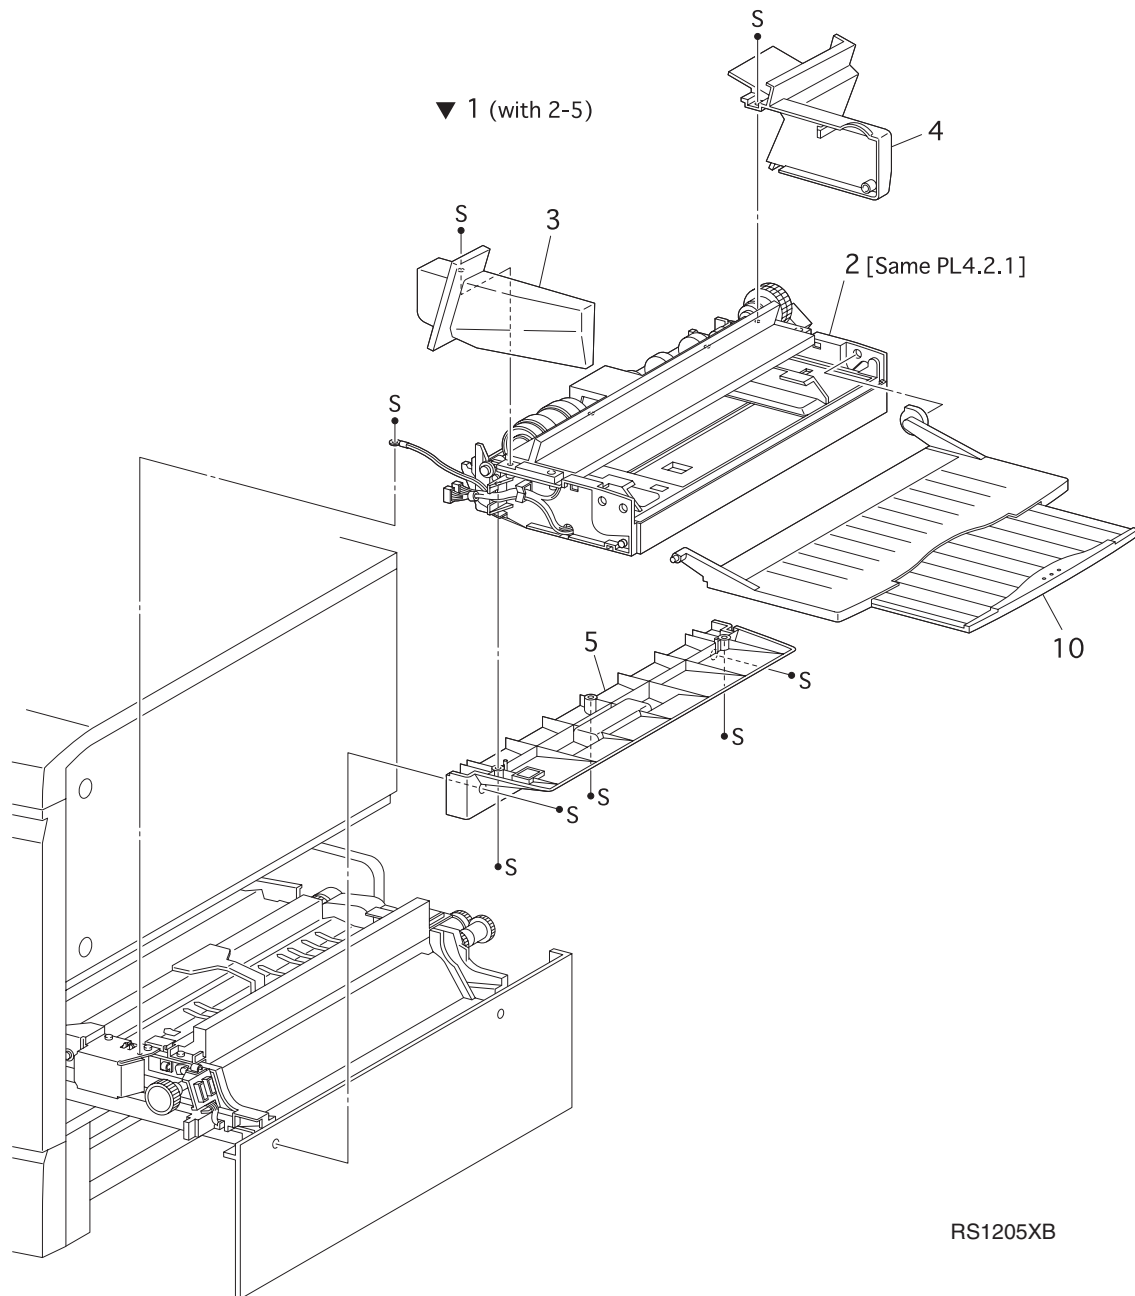
PL4.1 Multi Sheet Inserter I (MSI)

- 1. MSI ASSEMBLY (with 2~5)P/N 865600K70231
- 2. MSI FRAME ASSEMBLY (same as PL4.2.1).....P/N 865600K70231
- 3. MSI FRONT COVERP/N 865048E48450
- 4. MSI REAR COVER.....P/N 865048E48462
- 5. MSI HOLDER.....P/N 865019E32251
- 10. MSI TRAY ASSEMBLYP/N 865050K36351

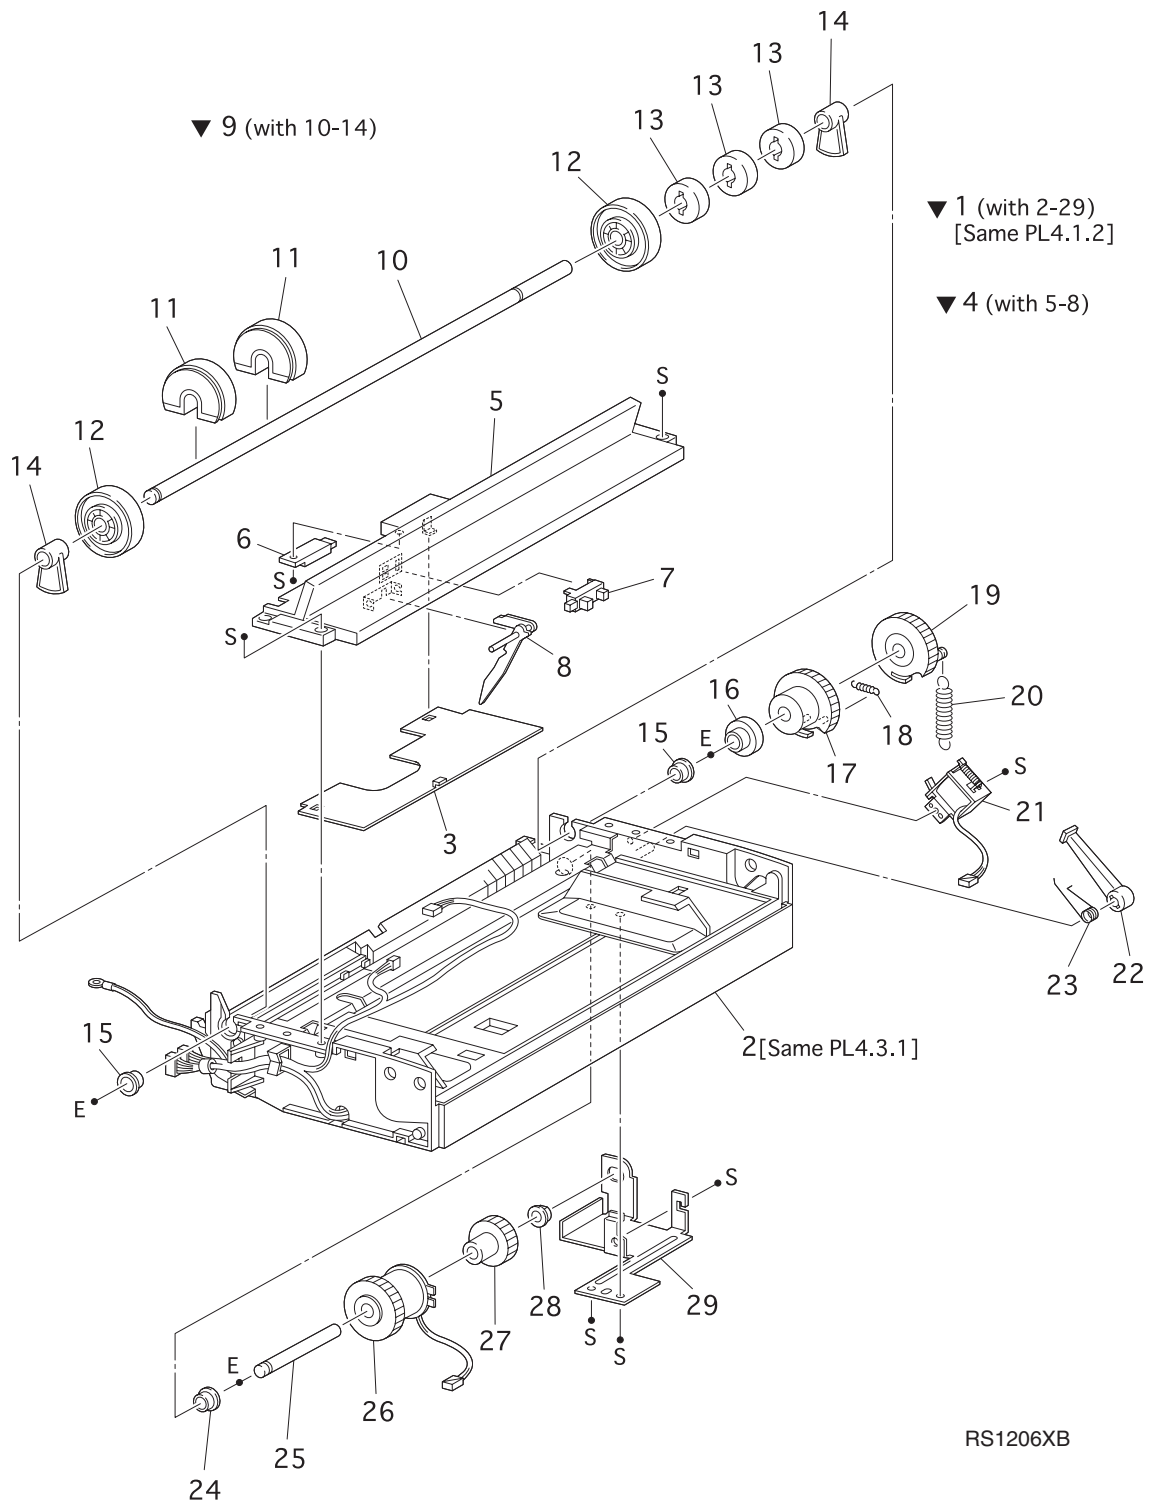
PL4.2 Multi Sheet Inserter II (MSI)

1. MSI FRAME ASSEMBLY (with 2~29) (same as PL 4.1.2).....	P/N 865600K70230
2. MSI SUB ASSEMBLY	N/A
3. MSI HARNESS COVER	N/A
4. MSI TOP COVER ASSEMBLY (with 5~8)	N/A

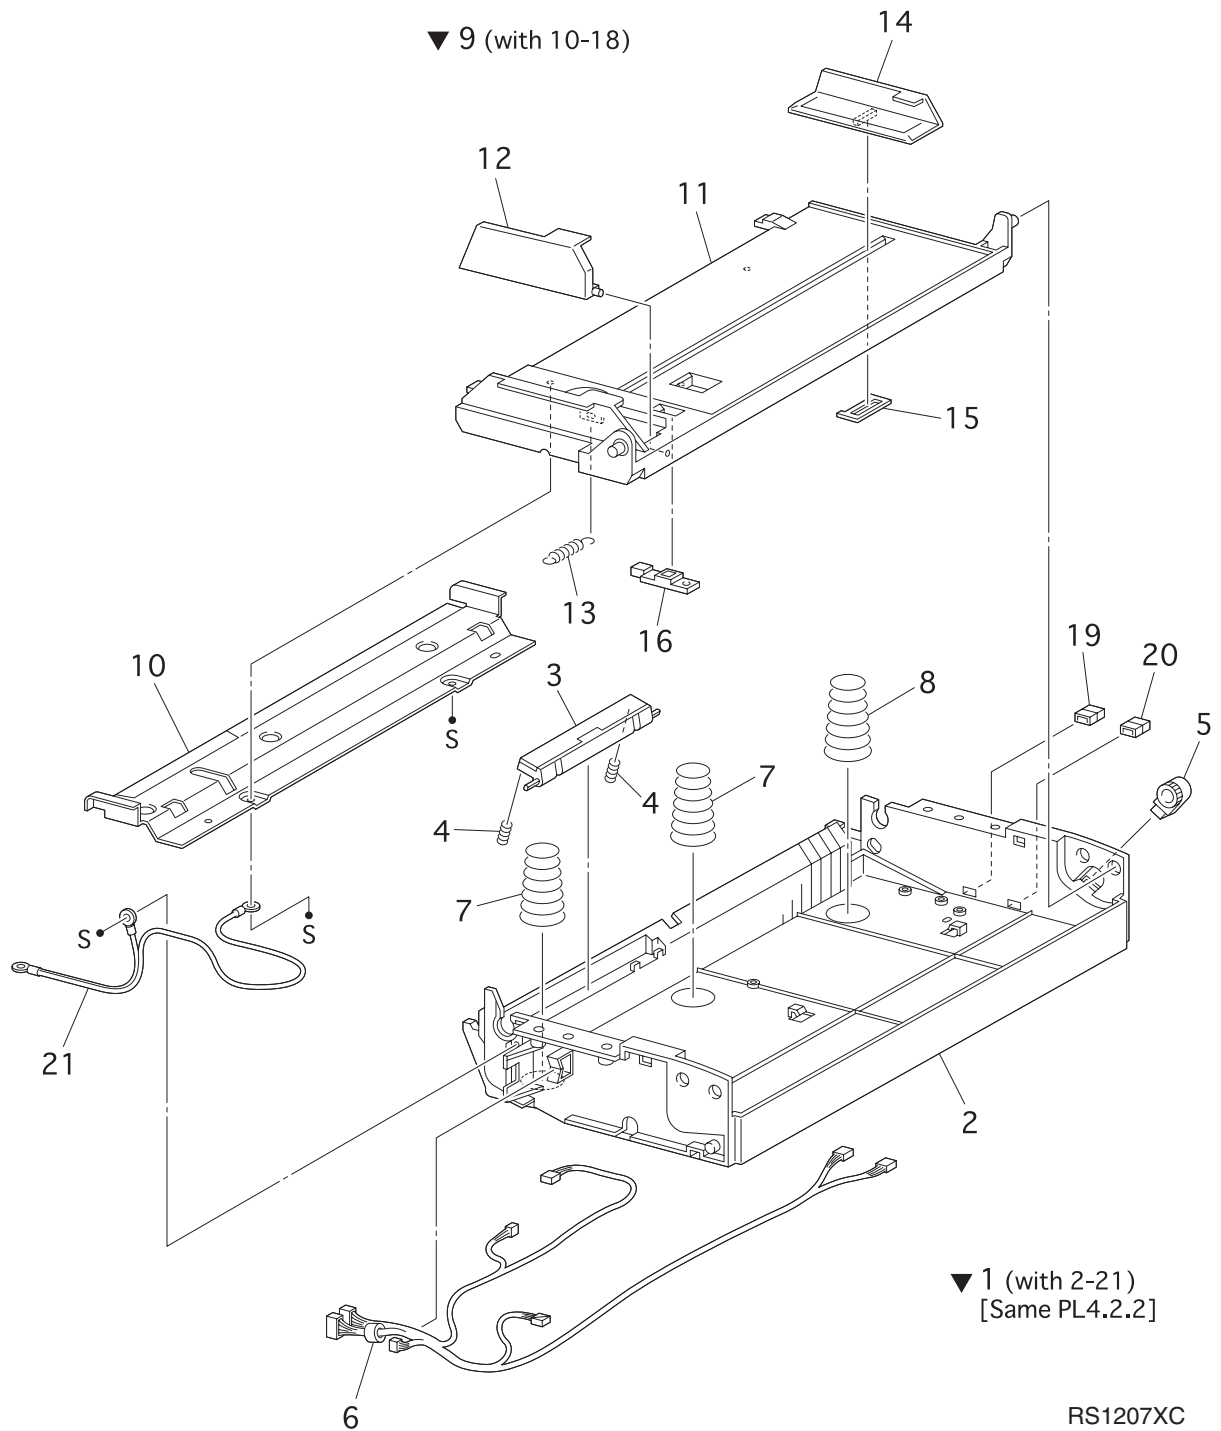
PL4.3 Multi Sheet Inserter III (MSI)

1. MSI SUB ASSEMBLY (with 2~21)	P/N 865600K70230
2. MSI FRAME	N/A
3. RETARD PAD ASSEMBLY	P/N 865600K68760
4. RETARD SPRING	N/A
5. OIL DAMPER GEAR	N/A
6. MSI HARNESS ASSEMBLY	N/A
7. MSI N/F FRONT SPRING	N/A
8. MSI N/F REAR SPRING	N/A
9. MSI BOTTOM ASSEMBLY (with 10~18)	N/A
10. MSI BOTTOM PLATEN/A	N/A
11. MSI BASE TRAY	N/A
12. MSI FRONT GUIDE	N/A
13. MSI GUIDE SPRING	N/A
14. MSI REAR GUIDE	N/A
15. GUIDE BLOCK	N/A
16. MSI LONG N/P SENSOR	N/A
19. CONNECTOR-2PW	N/A
20. CONNECTOR-2PB	N/A
21. MSI EARTH WIRE	N/A

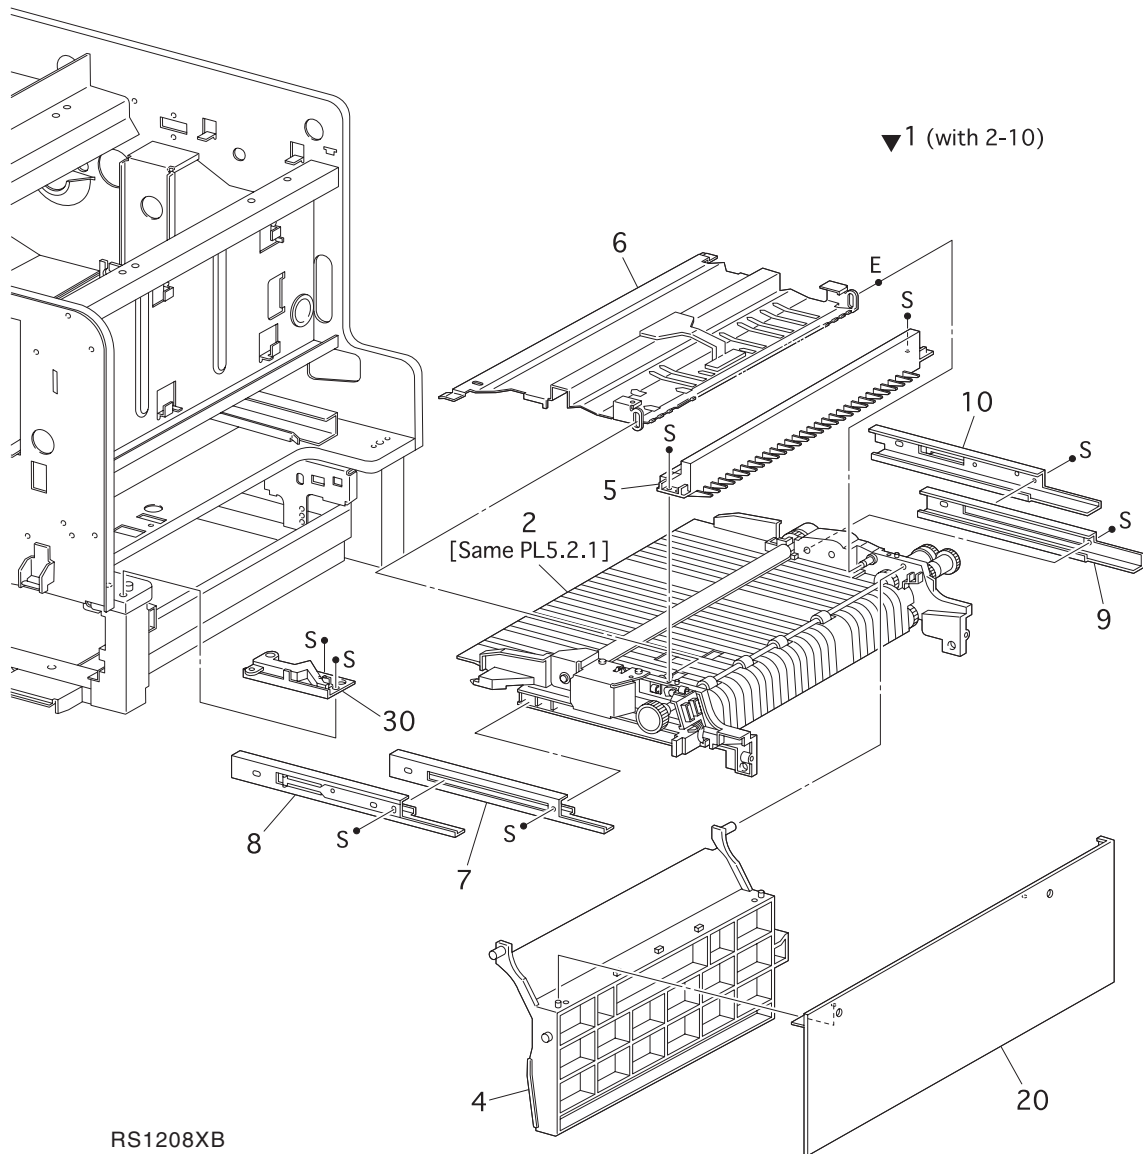
PL5.1 Paper Transportation I

1. MAIN P/H ASSEMBLY (with 2~10)	N/A
2. MAIN P/H SUB ASSEMBLY (Same as PL 5.2.1)	N/A
4. P/H TURN CHUTE ASSEMBLY	P/N 865054K06742
5. PRE-REGISTRATION CHUTE ASSEMBLY	N/A
6. REGISTRATION CHUTE ASSEMBLY	N/A
7. P/H FRONT RAIL-S	N/A
8. P/H FRONT RAIL-L	N/A
9. P/H REAR RAIL-S	N/A
10. P/H REAR RAIL-L	N/A
20. MAIN P/H COVER	N/A
30. LATCH ARM ASSEMBLY	P/N 865031K92400
